## Instructions for Fitting the Viton O-Ring Seal and E-Zee 'White Clip' to the Fuel Filter Module Rover 75 and MG ZT late-2001 onwards (petrol models only)

This kit will fix the common non-start condition due to filter module separation. Both fuel pump and fuel filter are located in the fuel tank. The filter module is under the LHS (nearside) rear seat. The pump is under the RHS (offside) rear seat. When ignition is switched on, you should hear the pump hum for 2-3 seconds. Incorrect fuel pressure at the engine will prevent it from starting. This is usually due to the filter case unscrewing, so causing pressure loss. It's a very common issue and can usually be fixed by fitting the MGR Retaining Clip (Part Number WJC000230). However, this item is rapidly becoming unobtainable. So, an alternative clip has been designed and manufactured. For easy cross-reference we've allocated this clip the Part Number WJC000230EZ. Development is continuous, so it may be subject to design and description changes in the future.

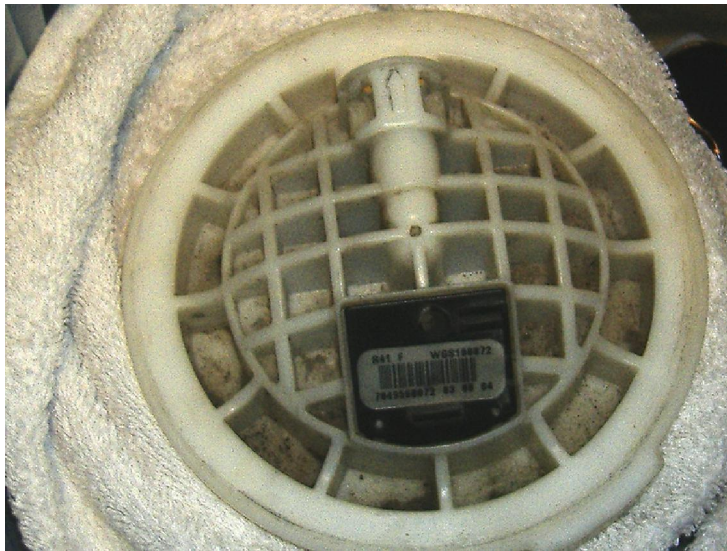
1. Remove rear seat cushion. This can be a chore and reference to the Haynes manual will help if you're unfamiliar with the way the seat is fastened. Displace the carpet and sound proofing mat on the LHS to find the access panel in the floor.
2. Remove the four bolts and lift the panel off. The white cap of filter module is underneath. It looks like this (seen removed from the tank).

If your filter unit looks different, with two loops on top for lifting it out, you have the earlier filter. This kit is not applicable and you should not proceed further.

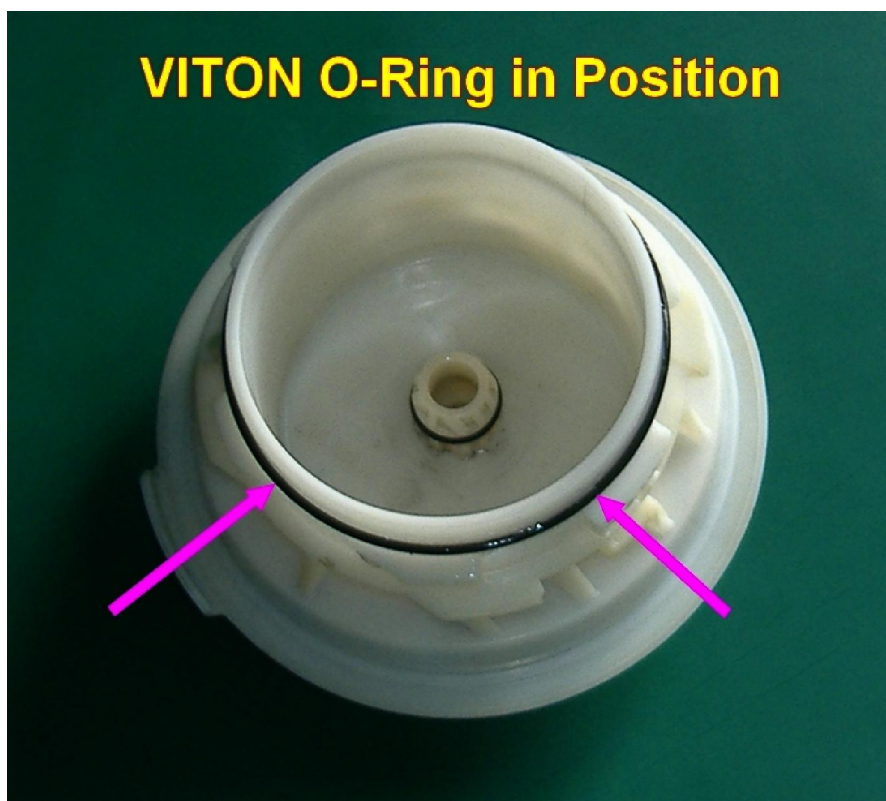
11. Carefully lubricate the new Viton O-Ring with silicone grease, lithium grease or Vaseline. Fit it onto the sealing flange as shown in the photo below. Ensure the ring is evenly seated all round.

It's recommended that the bayonet lugs on the outside of the cap as well as the small o-ring on the central spigot are also greased as this will make refitting the cap much easier.

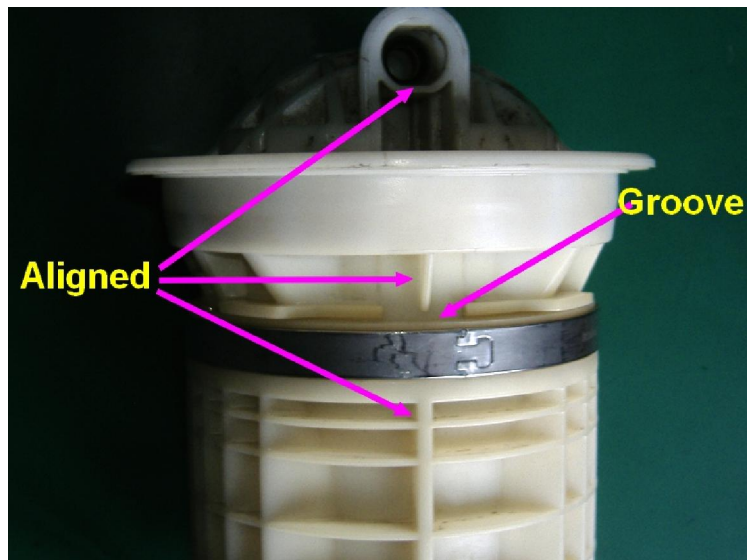
13. Carefully replace the cap into the case using a twisting motion to enter its spigot into the filter element core. The cap will only enter the case in one position. Press it into the body to engage the bayonet and turn the cap clockwise. It comes to a hard stop after one eighth turn. Again, tightening may require considerable effort. When correctly tightened, the vertical ribs on the cap and case will align so the retaining clip can be fitted. The next photo explains it. For illustration purposes, the module here has been removed from the tank.

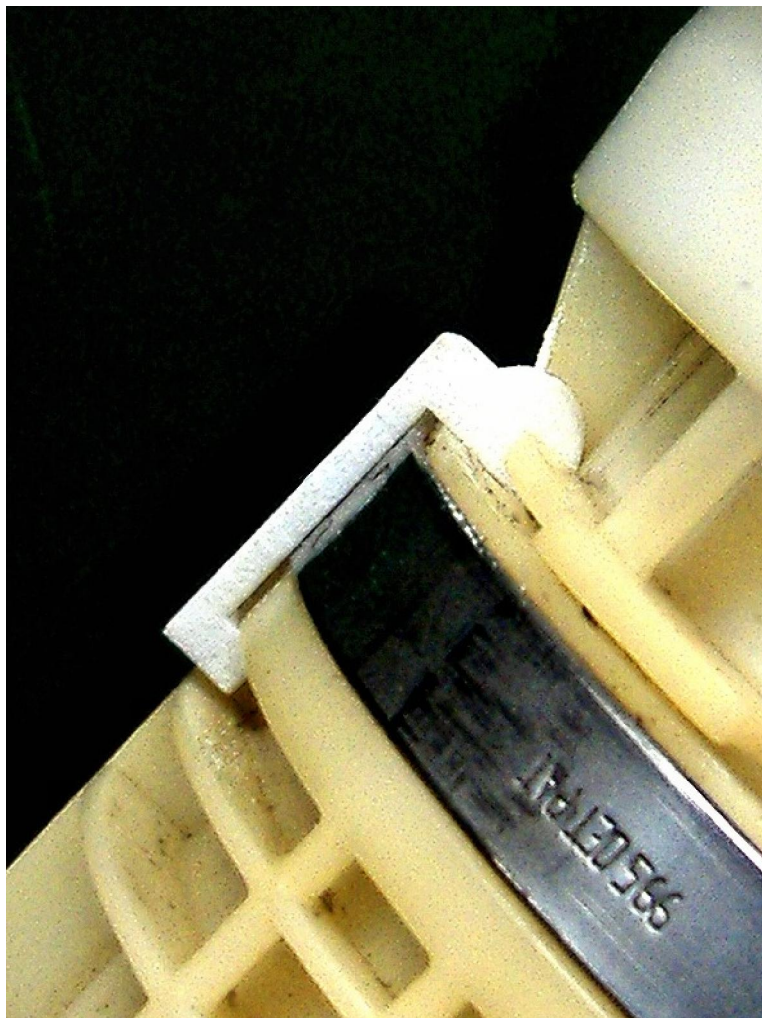
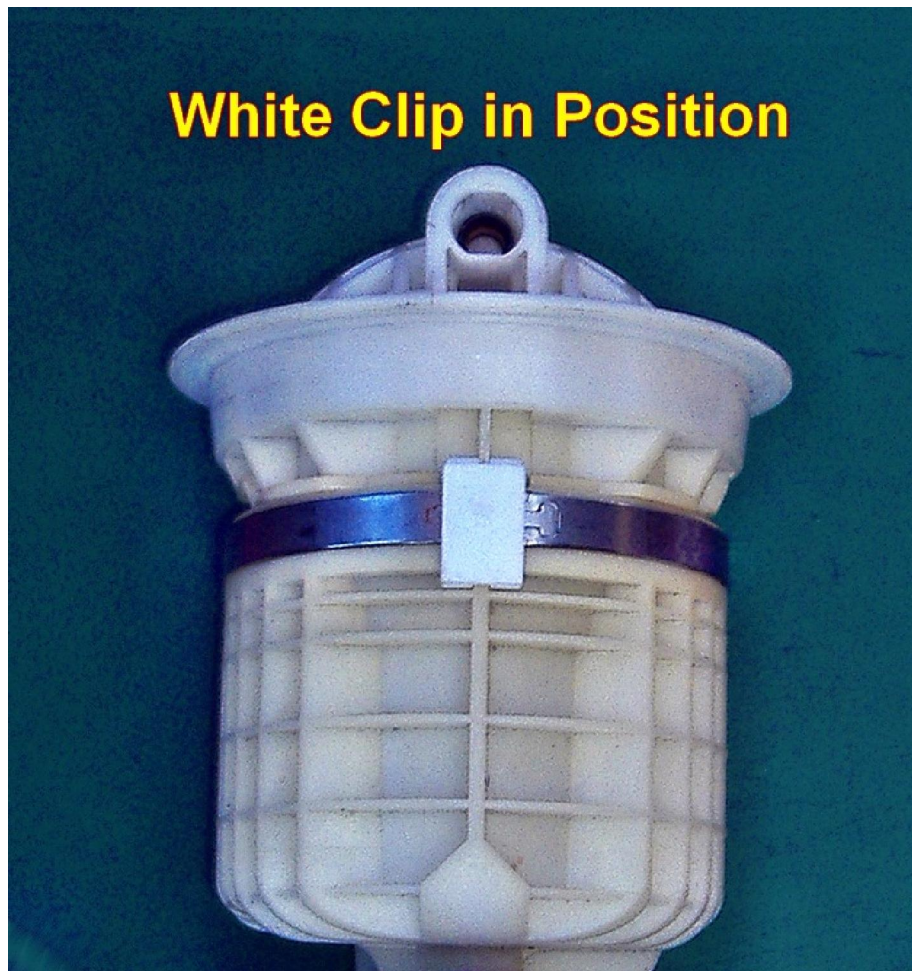
14. The White Clip can now be fitted. It goes over the rib directly under the pipe socket and across the steel band. To fit the clip, insert the T-shaped lugs around the upper rib and into the groove above the steel band. Now press the lower end across the vertical rib on the case. The clip should snap into place. This will prevent the case from slackening in the future. The photos below show the correct result.

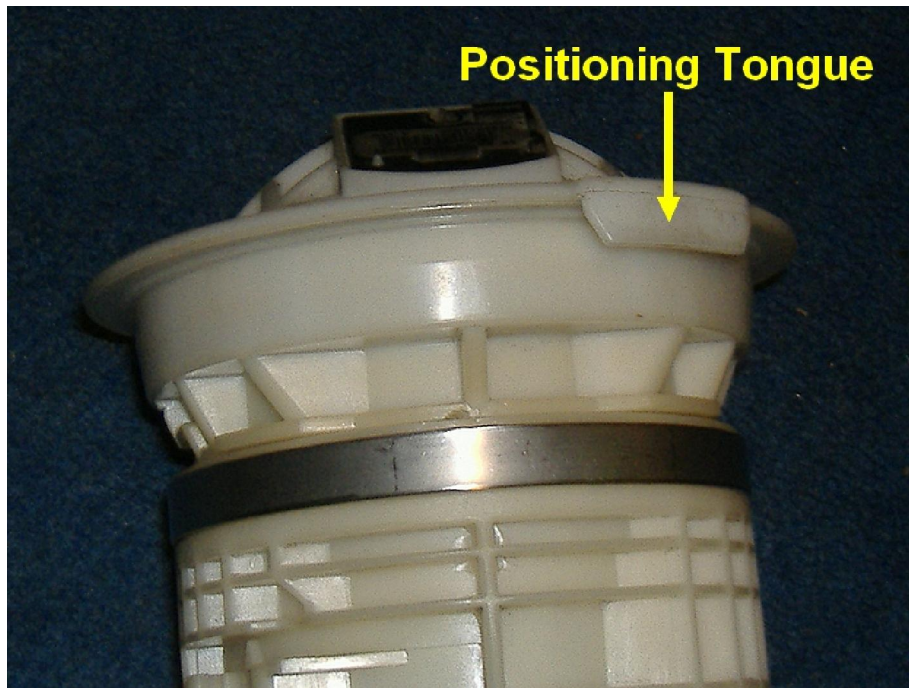
**16. Carefully lower the module back into the port. The downward facing tongue on the cap (shown below) is positioned to the cutaway in the port rim. This ensures the level float system is clear of obstructions.**
